# USS NASHVILLE (LPD-13) SEMAT II HULL AND SUPPORTING STRUCTURE SURVEY

7/22/02 TO 8/2/02

**USS NASHVILLE (LPD-13)**  
**SEMAT II**  
**SHELL AND SUPPORTING STRUCTURE SURVEY, INTERIOR AREAS.**

A SEMAT II UNDERWATER HULL AND SUPPORTING STRUCTURE SURVEY OF INTERIOR AREAS WAS CONDUCTED ON BOARD **USS NASHVILLE (LPD-13)** FROM 07/22/02 TO 08/02/02 AT NAVAL STATION, NORFOLK VIRGINIA.

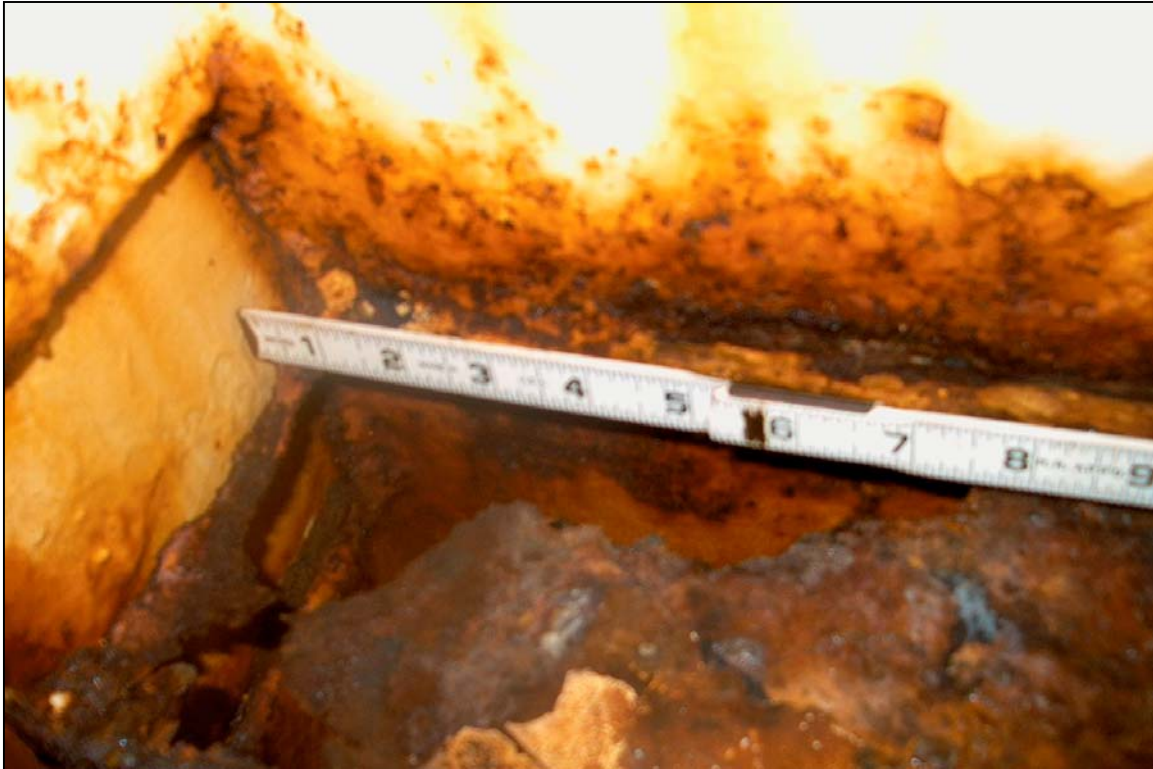
<b>SAFETY HAZARD:</b> 1. SERIOUS - CORRECT AS SOON AS POSSIBLE 2. SERIOUS - SUSPENSION OF EQUIPMENT/SYSTEM/SPACE REQUIRED 3. SERIOUS - WAVIER OF EQUIPMENT/SYSTEM 4. SAFETY ITEM - MINOR 5. COMBUSTIBLE MATERIAL		1. MAINTENANCE ACTION COMPLETED: PARTS DRAWN FROM SUPPLY 2. MAINTENANCE ACTION COMPLETED: REQUIRED PARTS NOT DRAWN FROM SUPPLY 3. MAINTENANCE ACTION COMPLETED: NO PARTS REQUIRED 4. CANCELLED - DEFERRAL WILL BE REMOVED FROM CSMP 5. MAINTENANCE ACTION COMPLETED: 3-M CAPABILITY UTILIZED 6. NONE OF THE ABOVE, DESCRIBE IN REMARKS/DESCRIPTION SECTION		1. MANDATORY 2. ESSENTIAL 3. HIGHLY DESIRABLE 4. DESIRABLE <b>4</b>	
<b>DISCREPANCY DESCRIPTION: PER SEMAT II UNDERWATER HULL ASSESSMENT: STERN GATE HYD OPERATOR EMERGENCY RIG-</b>					
<b>CONN SPACE (4-268-2-Q), BASIN WALL IS THINNING ALONG DECK-FROM FWD BLKD TO TRANSOM. THINNING IS ALSO OCCURRING</b>					
<b>AT THE TRANSOM-FROM THE DECK TO THE OVHD AND ABOVE THE UPPER STRINGER. FWD END OF UPPER STRINGER IS HOLED.</b>

PORT SIDE, DETERIORATED 2<sup>ND</sup> STRINGER FROM THE DECK, OUTBOARD SIDE OF WELL DECK. JSN A367

<b>REFER TO DRAWING FOR UT READINGS.</b>					
<b>RECOMMENDED REPAIRS: RECOMMEND REPAIR ACTIVITY CUT OUT AND REPLACE APPROXIMATELY 40SQF OF BASIN WALL,</b>					
<b>USING .375 OS. RECOMMEND REPLACING BOTH 6X4 T- BEAMS, APPROX 16LF. PRIME AND PAINT.</b>					
<b>SSPORT C221 POC: B. WILLIAMS (757) 396-4001 TPOC: C.BUCK (757) 396-4001</b>					
<b>CSMP SUMMARY</b> BASIN WALL IS THINNING/ STRINGER HOLED				<b>TEST#</b> MRC 1102/1	
<b>ROOT CAUSE/AMPLIFICATION:</b> H1				<b>STEP#</b> 1 THRU 5	
<b>SYSTEM LEVEL IMPACT:</b>					
PART NO.	NOMENCLATURE		QTY	NSN	COST
1					
2					
3					
4					
5					
6					
FIRST CONTACT <b>BUYNA</b>		RATE <b>HT1</b>	SECOND CONTACT <b>TEECE</b>		PHONE
ASSESSOR / ACT / TECH ID# J.LAROCK /C.SHORT QED SYSTEMS INC. (757-490-5047)			TD	TL	LOGISTICIAN
					TSP

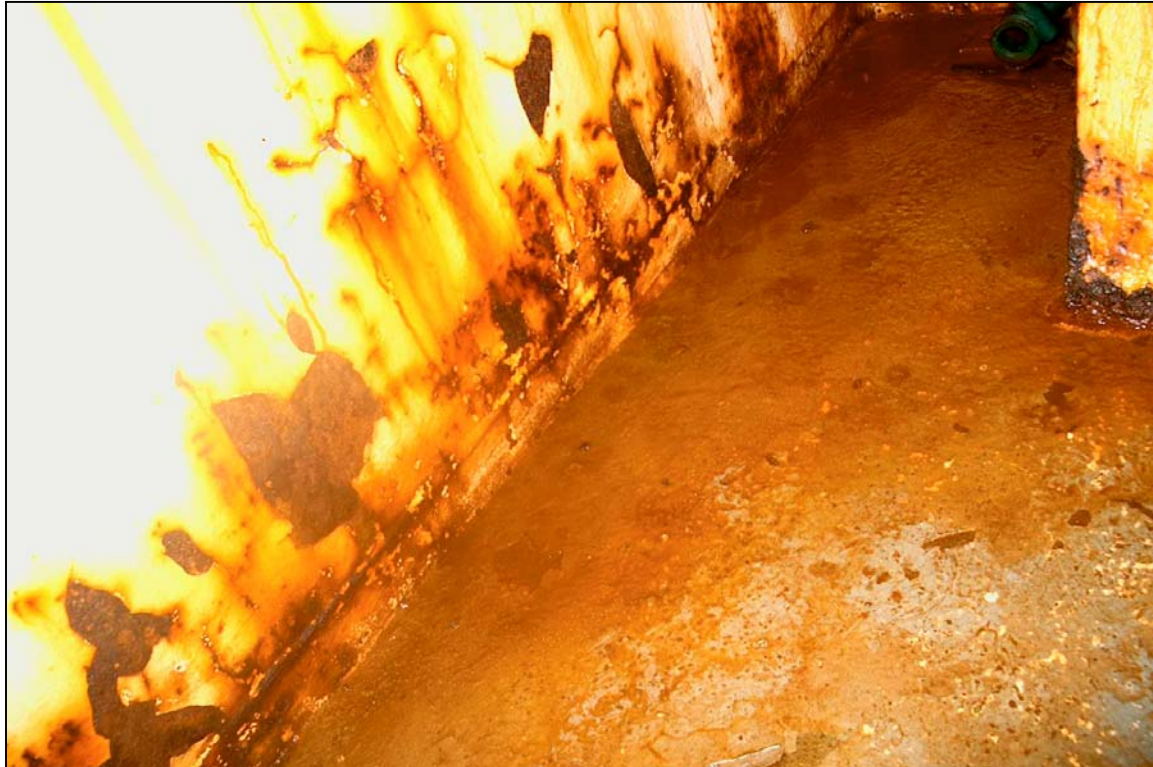
CORROSION AT DECK, OUTBOARD SIDE OF PORT WELL DECK. SEVERAL LOW U/T READINGS WERE REVEALED IN THIS AREA. REFER TO DRAWING. JSN A367

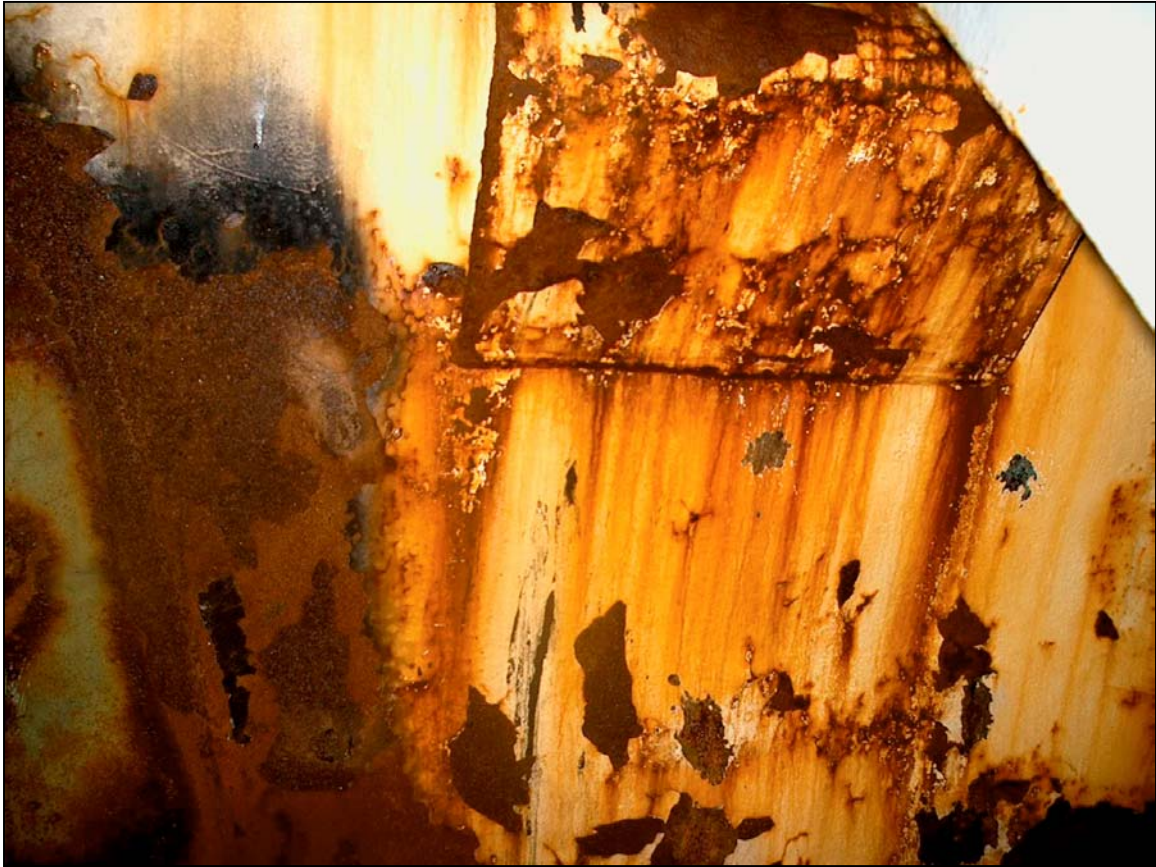
<b>SSPORT C221 POC: B. WILLIAMS (757) 396-4001 TPOC: C.BUCK</b>					
<b>CSMP SUMMARY</b>				<b>TEST#</b>	
CORRODED BLKDS (4-268-2-Q)				MRC 1102/1	
<b>ROOT CAUSE/AMPLIFICATION:</b>				<b>STEP#</b>	
H1				1 THRU 5	
<b>SYSTEM LEVEL IMPACT:</b>					
PART NO.		NOMENCLATURE		QTY	NSN
1					
2					
3					
4					
5					
6					
FIRST CONTACT <b>BUYNA</b>		RATE <b>HT1</b>	SECOND CONTACT <b>TEECE</b>		PHONE
ASSESSOR / ACT / TECH ID# J.LAROCK /C.SHORT QED SYSTEMS INC. (757-490-5047)		TD	TL	LOGISTICIAN	TSP

HEAVY PAINT SEPARATION AND RUST ON FORWARD BULKHEAD. U/T  
READINGS SHOW NO SIGNIFICANT METAL LOSS.REFER TO DRAWING.  
JSN A368

SAFETY HAZARD: 1. SERIOUS - CORRECT AS SOON AS POSSIBLE 2. SERIOUS - SUSPENSION OF EQUIPMENT/SYSTEM/SPACE REQUIRED 3. SERIOUS - WAVIER OF EQUIPMENT/SYSTEM 4. SAFETY ITEM - MINOR 5. COMBUSTIBLE MATERIAL		1. MAINTENANCE ACTION COMPLETED: PARTS DRAWN FROM SUPPLY 2. MAINTENANCE ACTION COMPLETED: REQUIRED PARTS NOT DRAWN FROM SUPPLY 3. MAINTENANCE ACTION COMPLETED: NO PARTS REQUIRED 4. CANCELLED - DEFERRAL WILL BE REMOVED FROM CSMP 5. MAINTENANCE ACTION COMPLETED: 3-M CAPABILITY UTILIZED 6. NONE OF THE ABOVE, DESCRIBE IN REMARKS/DESCRIPTION SECTION			1. MANDATORY 2. ESSENTIAL 3. HIGHLY DESIRABLE 4. DESIRABLE  <b>4</b>
<b>DISCREPANCY DESCRIPTION: PER SEMAT II UNDERWATER HULL ASSESSMENT: PORT STERN GATE HYDRAULIC OPERATOR</b>					
EMERGENCY RIG -CONN SPACE (4-268-2-Q) HAS HEAVY CORROSION ON FWD BLKD, SHELL AND TRANSOM. APPROX. 200 SF.					
<b>RECOMMENDED REPAIRS: SHIPS FORCE CLEAN TO BARE METAL, PRIME AND PAINT. APPROX. 200 SF.</b>

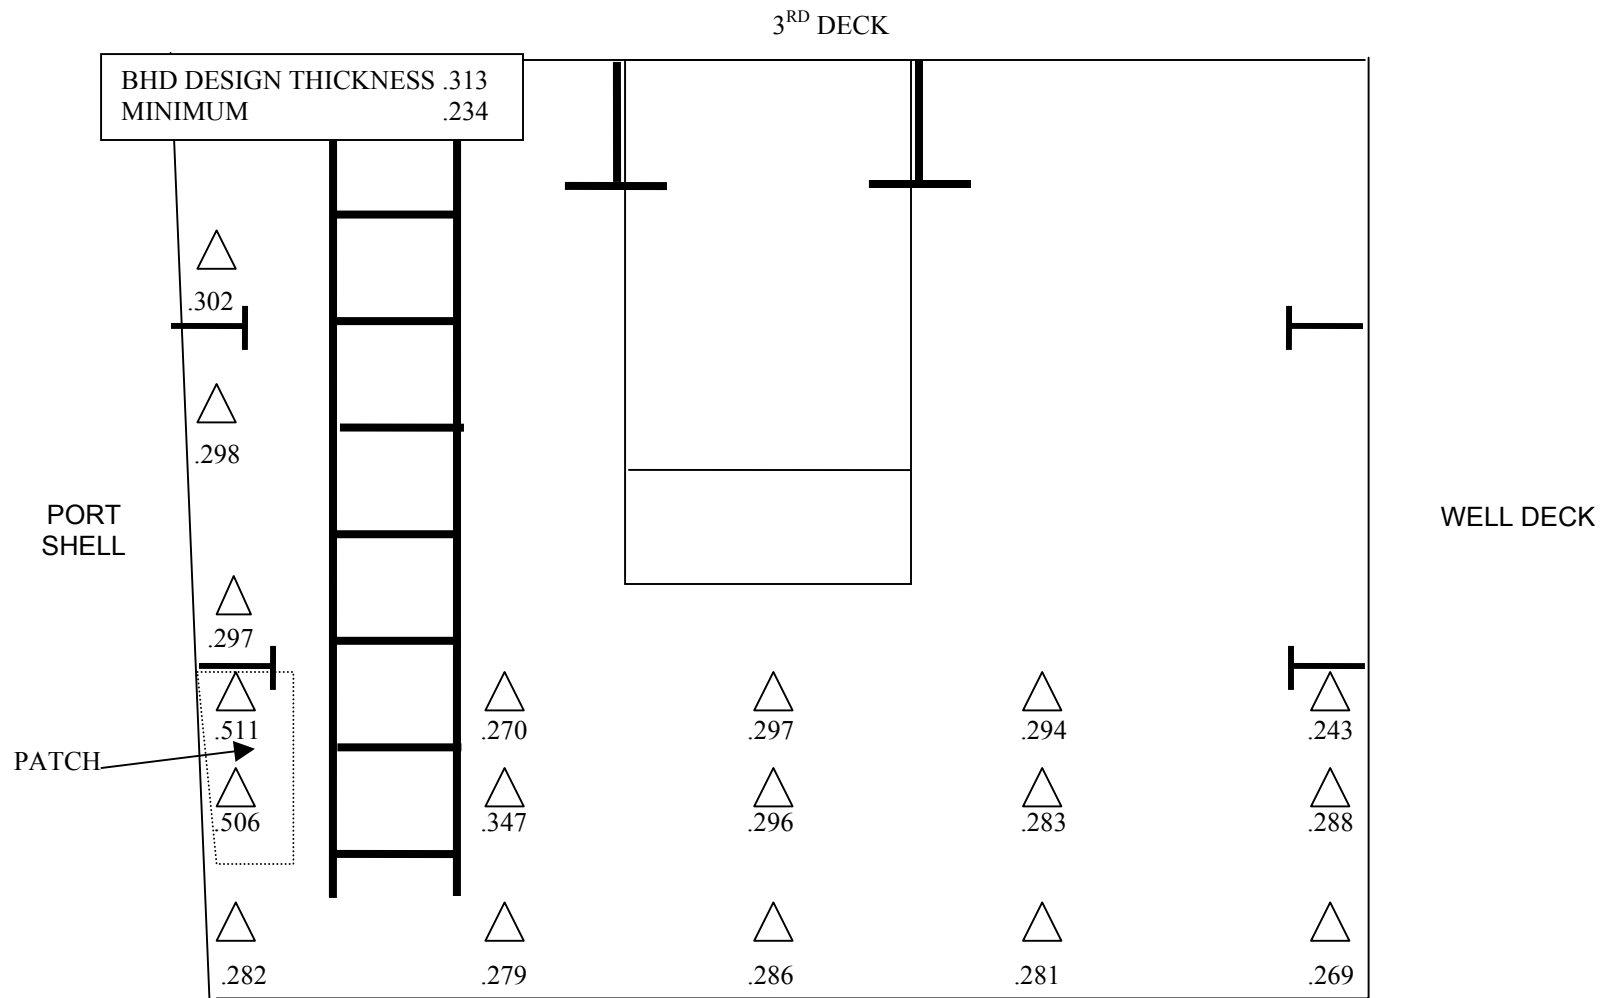
USS NASHVILLE (LPD-13) STERN GATE HYD OPERATOR  
EMERGENCY RIG-CONN SPACE (4-268-2-Q)

8x6" hole in web,  
at Fr. 268

△ .373	△ .366	△ .370	▲ .286	△ .378	▲ .250	▲ .259
4 X 6 T-BEAM						
	F .102	F .132	F .103	F .098	F .167	F .165
△ .371	△ .377	△ .367	△ .314	△ .375	△ .335	▲ .194
△ .375	△ .378	△ .377	△ .376	△ .380	△ .364	▲ .164
△ .344	△ .319	△ .368	△ .349	△ .367	△ .364	△ .312
4 X 6 T-BEAM						
F .191		F .197	F .188		F .174	F .184
W .186		W .236	W .237		W .210	W .211
△ .324	△ .378	△ .322	△ .320	△ .352	▲ .227	▲ .197
△ .374	△ .371	△ .377	△ .337	△ .377	△ .375	△ .325
▲ .261	▲ .227	▲ .217	△ .310	▲ .249	△ .290	△ .292

Design Thickness .375  
Minimum .287  
Flange  
Web

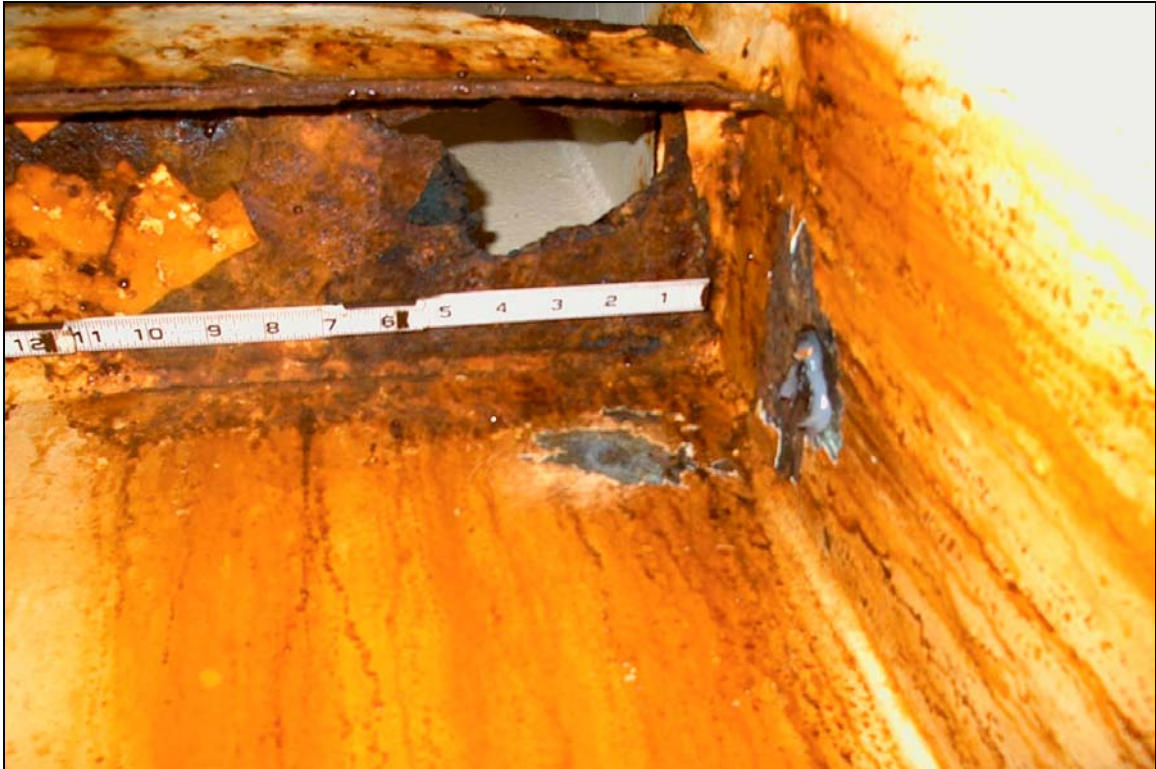
<b>SSPORT C221 POC: B. WILLIAMS (757) 396-4001 TPOC: C.BUCK</b>					
<b>CSMP SUMMARY</b> BASIN WALL IS THINNING/ HOLED STRINGER (4-268-1-Q)				<b>TEST#</b> MRC 1102/1	
<b>ROOT CAUSE/AMPLIFICATION:</b> H1				<b>STEP#</b> 1 THRU 5	
<b>SYSTEM LEVEL IMPACT:</b>					
PART NO.	NOMENCLATURE		QTY	NSN	COST
1					
2					
3					
4					
5					
6					
FIRST CONTACT <b>BUYNA</b>		RATE <b>HT1</b>	SECOND CONTACT <b>TEECE</b>		PHONE
ASSESSOR / ACT / TECH ID# J.LAROCK /C.SHORT QED SYSTEMS INC. (757-490-5047)			TD	TL	LOGISTICIAN TSP

HOLED 2<sup>ND</sup> STRINGER, ON INBOARD SIDE OF BASIN WALL AT BULKHEAD 268.

SAFETY HAZARD: 1. SERIOUS - CORRECT AS SOON AS POSSIBLE 2. SERIOUS - SUSPENSION OF EQUIPMENT/SYSTEM/SPACE REQUIRED 3. SERIOUS - WAIVER OF EQUIPMENT/SYSTEM 4. SAFETY ITEM - MINOR 5. COMBUSTIBLE MATERIAL		1. MAINTENANCE ACTION COMPLETED: PARTS DRAWN FROM SUPPLY 2. MAINTENANCE ACTION COMPLETED: REQUIRED PARTS NOT DRAWN FROM SUPPLY 3. MAINTENANCE ACTION COMPLETED: NO PARTS REQUIRED 4. CANCELLED - DEFERRAL WILL BE REMOVED FROM CSMP 5. MAINTENANCE ACTION COMPLETED: 3-M CAPABILITY UTILIZED 6. NONE OF THE ABOVE, DESCRIBE IN REMARKS/DESCRIPTION SECTION		1. MANDATORY 2. ESSENTIAL 3. HIGHLY DESIRABLE 4. DESIRABLE	
<b>DISCREPANCY DESCRIPTION: PER SEMAT II UNDERWATER HULL ASSESSMENT: (4-268-1-Q) STERN GATE EMERGENCY RIG CONN</b>					
SPACE. BASIN WALL IS THINNING ALONG THE DECK. 2 <sup>ND</sup> STRINGER FROM DECK IS HOLED AT FWD BHD.					
<b>RECOMMENDED REPAIRS: RECOMMEND REPAIR ACTIVITY CUT OUT AND REPLACE APPROXIMATELY 40SQF OF BASIN WALL, USING .375 OS. RECOMMEND REPLACING BOTH 6X4 T- BEAMS, APPROX 16LF. PRIME AND PAINT.</b>

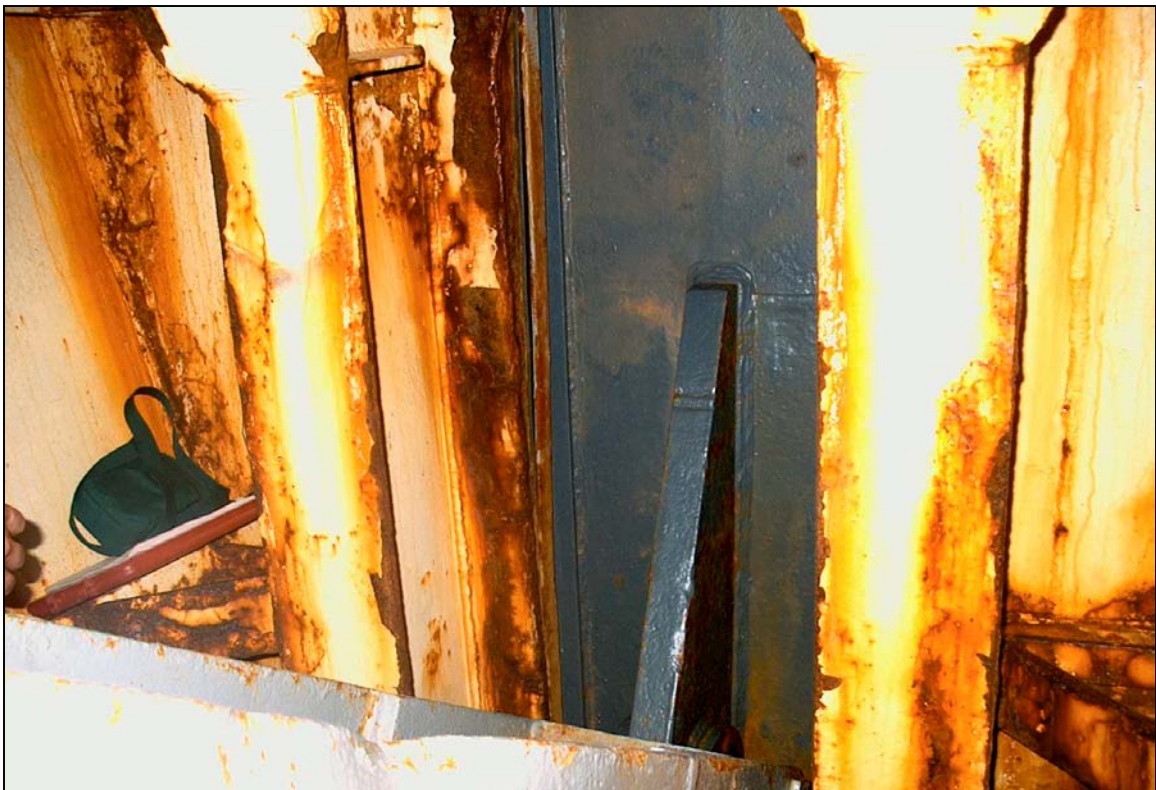
CORROSION ON THE TRANSOM

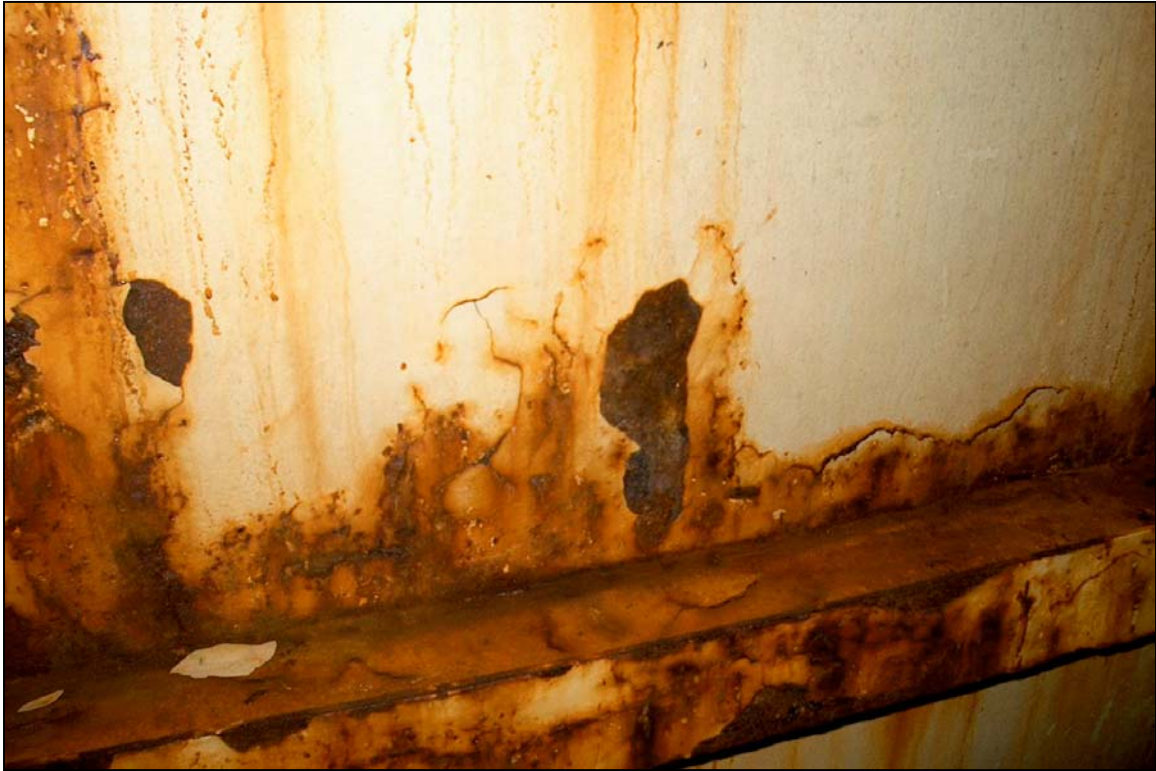
CORROSION ON THE SHELL.

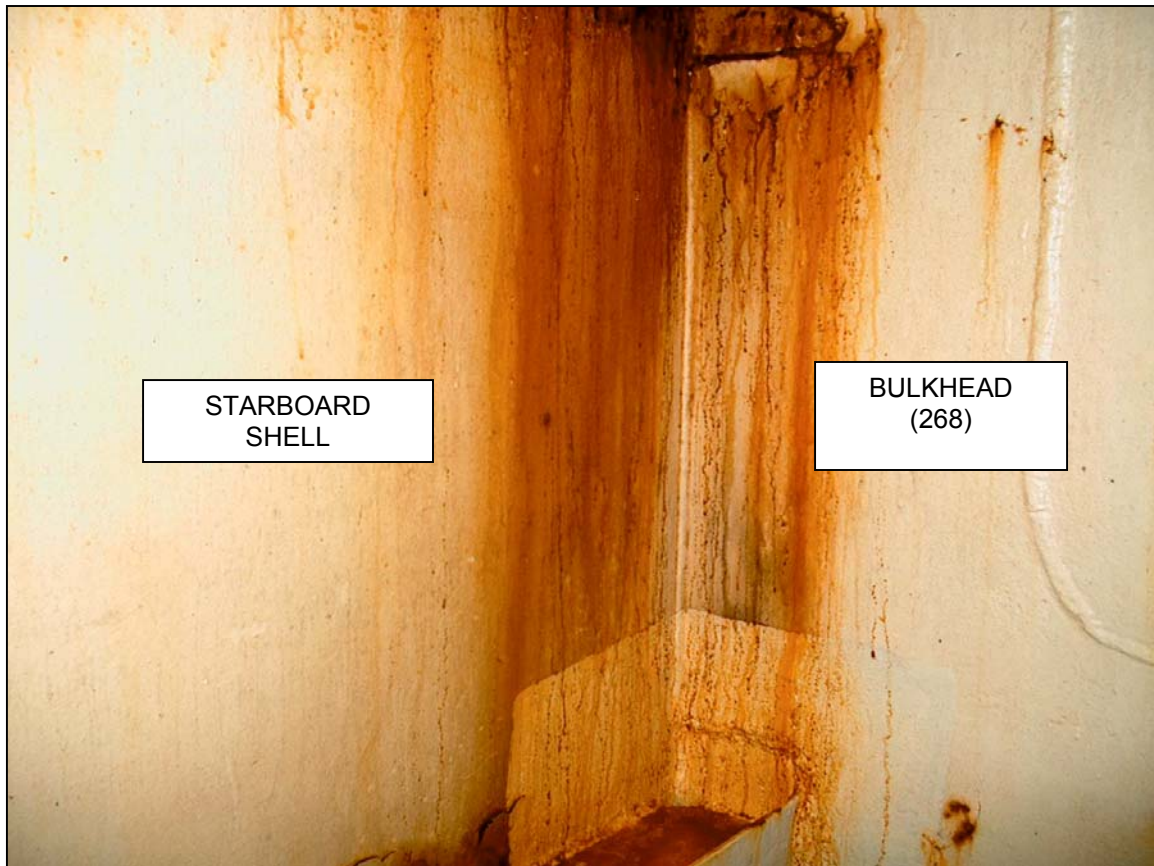
<b>SSPORT C221 POC: B. WILLIAMS (757) 396-4001 TPOC: C.BUCK</b>					
<b>CSMP SUMMARY</b>				<b>TEST#</b> MRC 1102/1	
<b>ROOT CAUSE/AMPLIFICATION:</b> H1				<b>STEP#</b> 1 THRU 5	
<b>SYSTEM LEVEL IMPACT:</b>					
PART NO.	NOMENCLATURE		QTY	NSN	COST
1					
2					
3					
4					
5					
6					
FIRST CONTACT <b>BUYNA</b>	RATE <b>HT1</b>	SECOND CONTACT <b>TEECE</b>	RATE <b>DC 1</b>	PHONE	
ASSESSOR / ACT / TECH ID# J.LAROCK /C.SHORT QED SYSTEMS INC. (757-490-5047)			TD	TL	LOGISTICIAN TSP

**CORROSION ON THE SHELL AND FORWARD BULKHEAD (268)**

<b>SAFETY HAZARD:</b> 1. SERIOUS - CORRECT AS SOON AS POSSIBLE 2. SERIOUS - SUSPENSION OF EQUIPMENT/SYSTEM/SPACE REQUIRED 3. SERIOUS - WAVIER OF EQUIPMENT/SYSTEM 4. SAFETY ITEM - MINOR 5. COMBUSTIBLE MATERIAL		1. MAINTENANCE ACTION COMPLETED: PARTS DRAWN FROM SUPPLY 2. MAINTENANCE ACTION COMPLETED: REQUIRED PARTS NOT DRAWN FROM SUPPLY 3. MAINTENANCE ACTION COMPLETED: NO PARTS REQUIRED 4. CANCELLED - DEFERRAL WILL BE REMOVED FROM CSMP 5. MAINTENANCE ACTION COMPLETED: 3-M CAPABILITY UTILIZED 6. NONE OF THE ABOVE, DESCRIBE IN REMARKS/DESCRIPTION SECTION		1. MANDATORY 2. ESSENTIAL 3. HIGHLY DESIRABLE 4. DESIRABLE	
<b>DISCREPANCY DESCRIPTION: PER SEMAT II UNDERWATER HULL ASSESSMENT:(4-268-1-Q ) STERN GATE EMERGENCY RIG CONN</b>					
SPACE HAS HEAVY CORROSION ON FWD BLKD, SHELL AND TRANSOM. APPROX. 200 SF.					
<b>RECOMMENDED REPAIRS: SHIPS FORCE CLEAN AREA TO BARE METAL, PRIME AND PAINT. APPROX. 200 SF.</b>

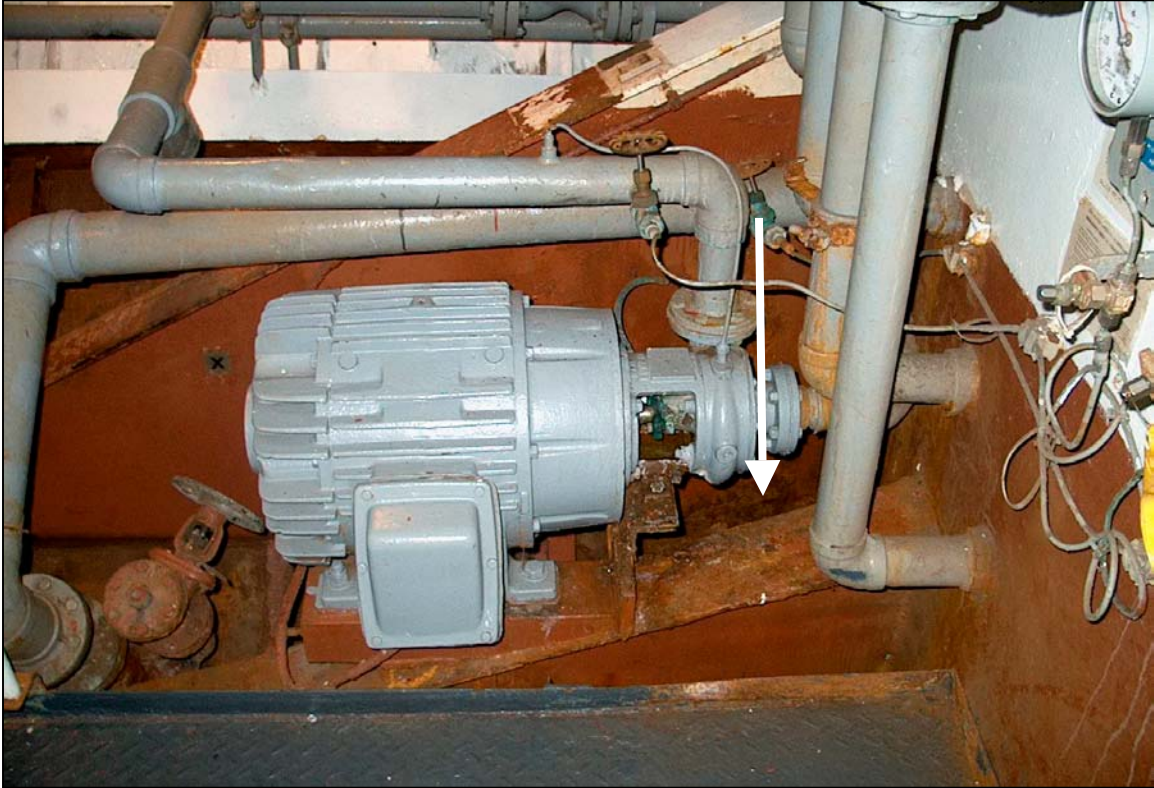
<b>SSPORT C221 POC: B. WILLIAMS (757) 396-4001 TPOC: C.BUCK</b>					
<b>CSMP SUMMARY</b>				<b>TEST#</b>	
ENTIRE SPACE NEEDS PRESERVATION (8-44-1-E)				MRC 1102/1	
<b>ROOT CAUSE/AMPLIFICATION:</b>				<b>STEP#</b>	
H1				1 THRU 5	
<b>SYSTEM LEVEL IMPACT:</b>					
PART NO.	NOMENCLATURE		QTY	NSN	COST
1					
2					
3					
4					
5					
6					
<b>FIRST CONTACT</b>		<b>RATE</b>	<b>SECOND CONTACT</b>		<b>PHONE</b>
<b>BUYNA</b>		<b>HT1</b>	<b>TEECE</b>		
ASSESSOR / ACT / TECH ID#			TD	TL	TSP
J.LAROCK /C.SHORT QED SYSTEMS INC. (757-490-5047)				LOGISTICIAN

PUMP AT BHD 52. ENTIRE SPACE HAS MILD CORROSION AND PAINT FAILURE.  
ARROW INDICATES CORROSION BELOW.

SAFETY HAZARD: 1. SERIOUS - CORRECT AS SOON AS POSSIBLE 2. SERIOUS - SUSPENSION OF EQUIPMENT/SYSTEM/SPACE REQUIRED 3. SERIOUS - WAVIER OF EQUIPMENT/SYSTEM 4. SAFETY ITEM - MINOR 5. COMBUSTIBLE MATERIAL		1. MAINTENANCE ACTION COMPLETED: PARTS DRAWN FROM SUPPLY 2. MAINTENANCE ACTION COMPLETED: REQUIRED PARTS NOT DRAWN FROM SUPPLY 3. MAINTENANCE ACTION COMPLETED: NO PARTS REQUIRED 4. CANCELLED - DEFERRAL WILL BE REMOVED FROM CSMP 5. MAINTENANCE ACTION COMPLETED: 3-M CAPABILITY UTILIZED 6. NONE OF THE ABOVE, DESCRIBE IN REMARKS/DESCRIPTION SECTION			1. MANDATORY 2. ESSENTIAL 3. HIGHLY DESIRABLE 4. DESIRABLE <b>4</b>
<b>DISCREPANCY DESCRIPTION: PER SEMAT II UNDERWATER HULL ASSESSMENT: FORWARD PUMP ROOM (8-44-1-E)</b>					
ENTIRE SPACE HAS MILD CORROSION AND PAINT SEPARATION, SHELL, BULKHEADS AND STRINGERS. APPROX. 500 SQF					
<b>RECOMMENDED REPAIRS: SHIPS FORCE POWER CLEAN ENTIRE SPACE TO BARE METAL, PRIME AND PAINT</b>

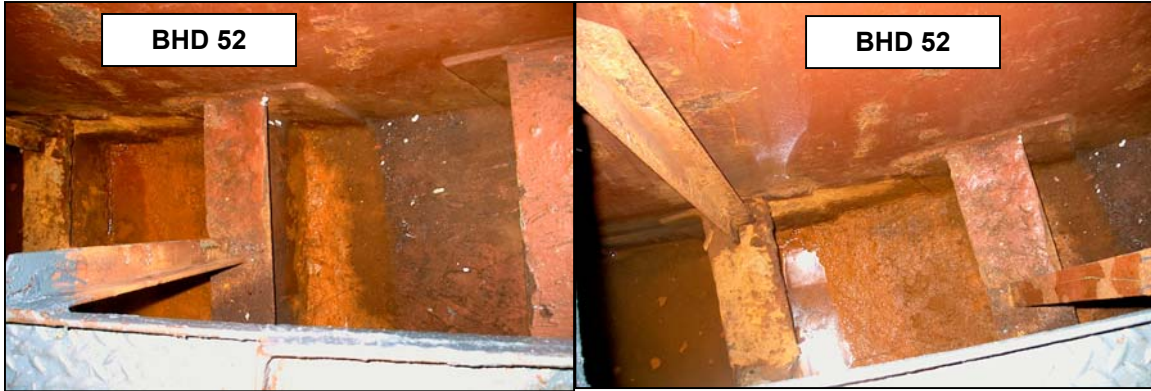
**CORROSION AND PAINT  
SEPARATION IN THE ENTIRE SPACE**

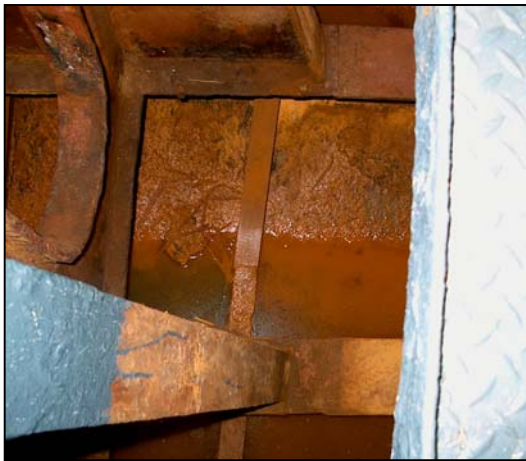
**TRAPPED WATER IS THE MAIN CAUSE  
OF CORROSION.**

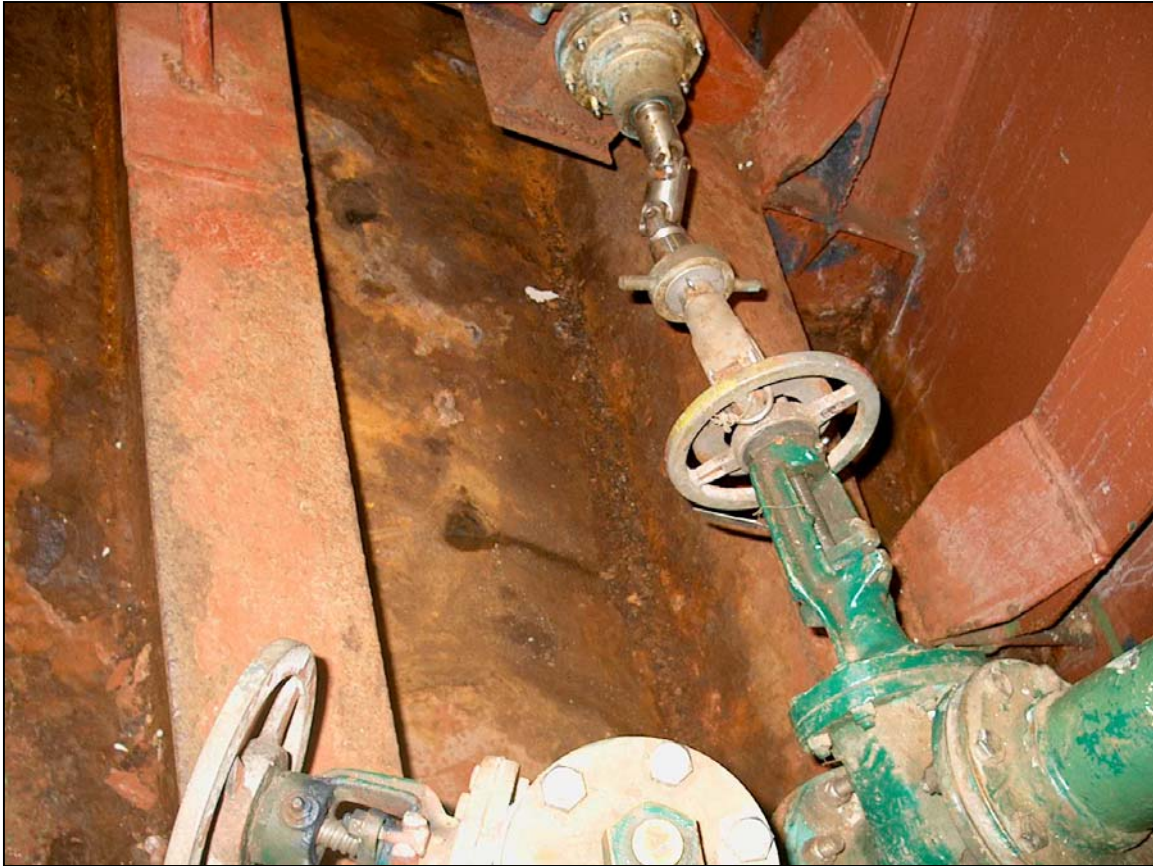
<b>SSPORT C221 POC: B. WILLIAMS (757) 396-4001 TPOC: C.BUCK (757) 396-4001</b>					
CSMP SUMMARY CORROSION ON SHELL (8-216-1-E)				TEST# MRC 1102/1	
ROOT CAUSE/AMPLIFICATION: H1				STEP# 1 THRU 5	
SYSTEM LEVEL IMPACT:					
PART NO.	NOMENCLATURE		QTY	NSN	COST
1					
2					
3					
4					
5					
6					
FIRST CONTACT BUYNA	RATE HT1	SECOND CONTACT TEECE	RATE DC 1	PHONE	
ASSESSOR / ACT / TECH ID# J.LAROCK /C.SHORT QED SYSTEMS INC. (757-490-5047)			TD	TL	LOGISTICIAN TSP

**CORROSION ON THE SHELL AND STRINGERS  
BETWEEN FRAMES (216-220). JSN A370**

SAFETY HAZARD: 1. SERIOUS - CORRECT AS SOON AS POSSIBLE 2. SERIOUS - SUSPENSION OF EQUIPMENT/SYSTEM/SPACE REQUIRED 3. SERIOUS - WAVIER OF EQUIPMENT/SYSTEM 4. SAFETY ITEM - MINOR 5. COMBUSTIBLE MATERIAL		1. MAINTENANCE ACTION COMPLETED: PARTS DRAWN FROM SUPPLY 2. MAINTENANCE ACTION COMPLETED: REQUIRED PARTS NOT DRAWN FROM SUPPLY 3. MAINTENANCE ACTION COMPLETED: NO PARTS REQUIRED 4. CANCELLED - DEFERRAL WILL BE REMOVED FROM CSMP 5. MAINTENANCE ACTION COMPLETED: 3-M CAPABILITY UTILIZED 6. NONE OF THE ABOVE, DESCRIBE IN REMARKS/DESCRIPTION SECTION		1. MANDATORY 2. ESSENTIAL 3. HIGHLY DESIRABLE 4. DESIRABLE <b>4</b>	
<b>DISCREPANCY DESCRIPTION: PER SEMAT II UNDERWATER HULL ASSESSMENT: GAS SYS. SW PUMP ROOM (8-216-1-E) LOCATED</b>					
<b>IN STARBOARD SHAFT ALLEY (8-184-1-Q) BETWEEN FRAMES (216-226) APPROX 100 SQF OF MILD CORROSION / SURFACE RUST ON</b>					
<b>SHELL AND FRAMES</b>					
<b>RECOMMENDED REPAIRS: RECOMMEND SHIPS FORCE POWER CLEAN AREA TO BARE METAL, PRIME AND PAINT APPROX 50 SQF</b>

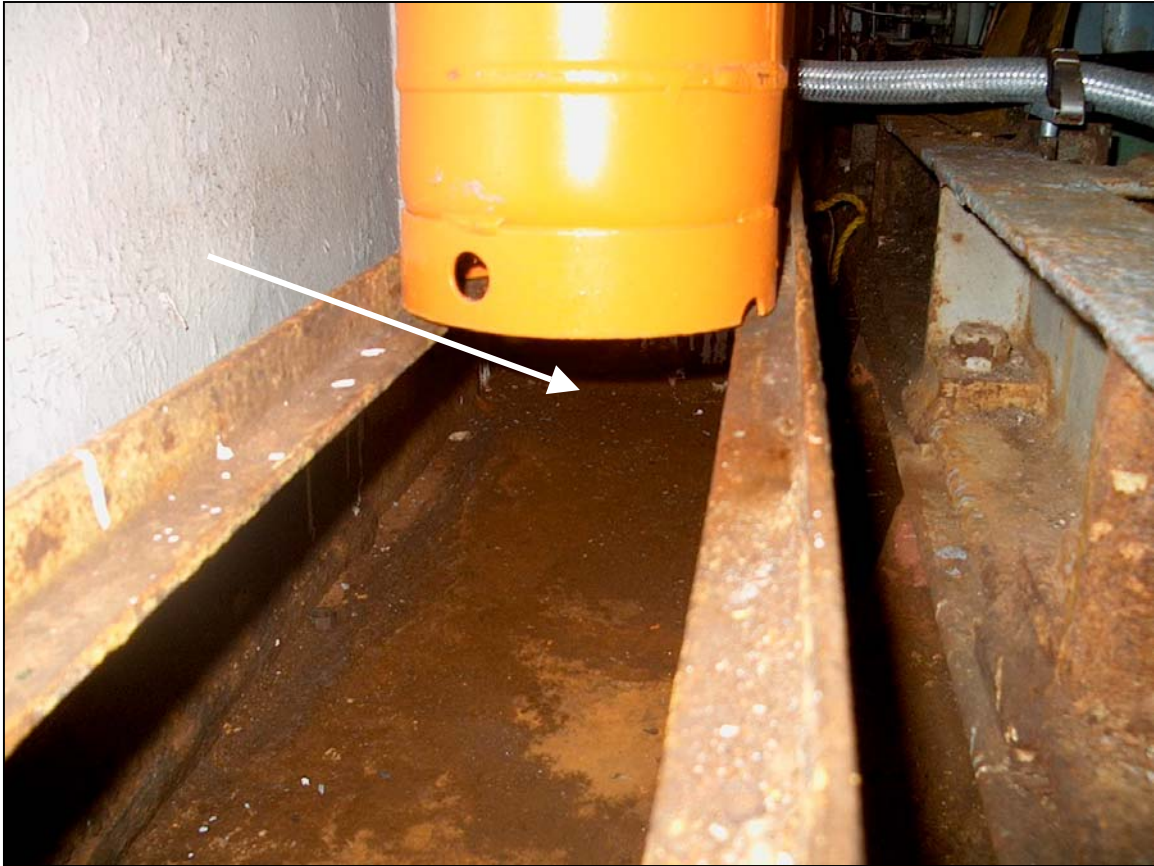
<b>SAFETY HAZARD:</b> 1. <b>SERIOUS - CORRECT AS SOON AS POSSIBLE</b> 2. <b>SERIOUS - SUSPENSION OF EQUIPMENT/SYSTEM/SPACE REQUIRED</b> 3. <b>SERIOUS - WAVIER OF EQUIPMENT/SYSTEM</b> 4. <b>SAFETY ITEM - MINOR</b> 5. <b>COMBUSTIBLE MATERIAL</b>		1. MAINTENANCE ACTION COMPLETED: PARTS DRAWN FROM SUPPLY 2. MAINTENANCE ACTION COMPLETED: REQUIRED PARTS NOT DRAWN FROM SUPPLY 3. MAINTENANCE ACTION COMPLETED: NO PARTS REQUIRED 4. CANCELLED - DEFERRAL WILL BE REMOVED FROM CSMP 5. MAINTENANCE ACTION COMPLETED: 3-M CAPABILITY UTILIZED 6. NONE OF THE ABOVE, DESCRIBE IN REMARKS/DESCRIPTION SECTION			1. MANDATORY 2. ESSENTIAL 3. HIGHLY DESIRABLE 4. DESIRABLE <b>3</b>
<b>DISCREPANCY DESCRIPTION: PER SEMAT II UNDERWATER HULL ASSESSMENT: AC MACHINERY ROOM NO. 1 (4-160-3-E), THE</b>					
<b>DECK/TANK TOP ALONG THE FWD STBD SIDE IS THINNING UNDER THE REFRIGERANT BOTTLE RACK. APPROX. 4 SF.</b>					
<b>BOTTLE RACK IS DAMAGED, PREVENTING BOTTLE REMOVAL AND DECK PRESERVATION. REFER TO DRAWING FOR</b>

ARROW INDICATES THINNING TANK TOP/DECK. REFER TO DRAWING FOR UT READINGS.  
JSN A369

<b>UT READINGS. TANK TOP IS (8-160-5-F)</b>					
<b>RECOMMENDED REPAIRS: REPAIR ACTIVITY CLEAN AND GAS FREE TANK (8-160-5-F). CUT OUT APPROX. 4 SF OF DECK/TANK TOP</b>					
<b>ALONG STBD SHELL, FROM FRAME 168 TO 164. REPLACE WITH .375 OS. PERFORM NDT ON TANK TOP. REPAIR</b>					
<b>BOTTLE RACK. PRIME AND PAINT.</b>					
<b>SSPORT C221 POC: B. WILLIAMS (757) 396-4001 TPOC: C.BUCK</b>					
<b>CSMP SUMMARY</b> THINNING DECK/TANK TOP, DAMAGED BOTTLE RACK (4-160-3-E)				<b>TEST#</b> MRC 1102/1	
<b>ROOT CAUSE/AMPLIFICATION:</b> H1				<b>STEP#</b> 1 THRU 5	
<b>SYSTEM LEVEL IMPACT:</b>					
PART NO.	NOMENCLATURE		QTY	NSN	COST
1					
2					
3					
4					
5					
6					
FIRST CONTACT <b>BUYNA</b>	RATE <b>HT1</b>	SECOND CONTACT <b>TEECE</b>	RATE <b>DC 1</b>	PHONE	
ASSESSOR / ACT / TECH ID# J.LAROCK /C.SHORT QED SYSTEMS INC. (757-490-5047)			TD	TL	LOGISTICIAN TSP

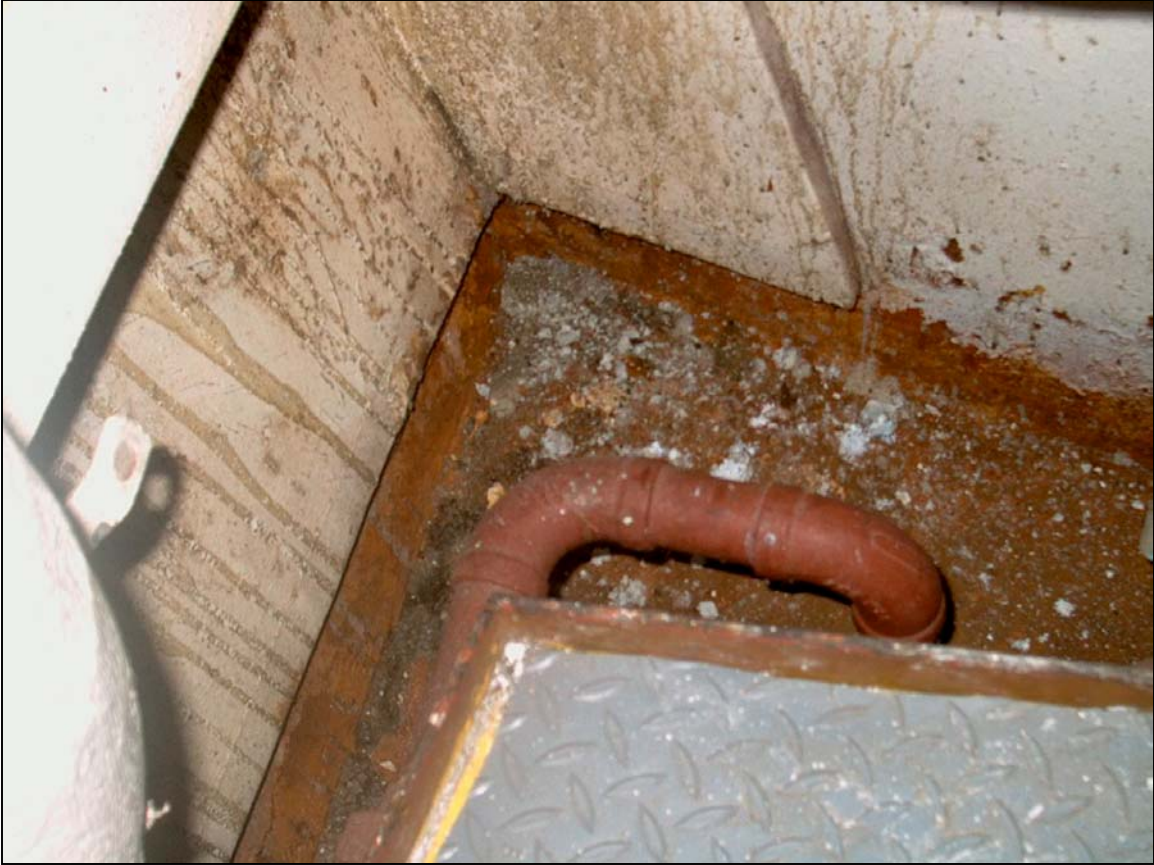
<b>SSPORT C221 POC: B. WILLIAMS (757) 396-4001 TPOC: C.BUCK</b>					
<b>CSMP SUMMARY</b> CORROSION ON DECK, SHELL AND BHD (68)				<b>TEST#</b> MRC 1102/1	
<b>ROOT CAUSE/AMPLIFICATION:</b> H1				<b>STEP#</b> 1 THRU 5	
<b>SYSTEM LEVEL IMPACT:</b>					
PART NO.	NOMENCLATURE		QTY	NSN	COST
1					
2					
3					
4					
5					
6					
FIRST CONTACT <b>BUYNA</b>		RATE <b>HT1</b>	SECOND CONTACT <b>TEECE</b>		PHONE
ASSESSOR / ACT / TECH ID# J.LAROCK / C.SHORT QED SYSTEMS INC. (757-490-5047)			TD	TL	LOGISTICIAN TSP

CORROSION ON SHELL, DECK AND BULKHEAD (68) AFT OF ELECTRICAL PANELS.  
JSN A366.

SAFETY HAZARD: 1. SERIOUS - CORRECT AS SOON AS POSSIBLE 2. SERIOUS - SUSPENSION OF EQUIPMENT/SYSTEM/SPACE REQUIRED 3. SERIOUS - WAIVER OF EQUIPMENT/SYSTEM 4. SAFETY ITEM - MINOR 5. COMBUSTIBLE MATERIAL		1. MAINTENANCE ACTION COMPLETED: PARTS DRAWN FROM SUPPLY 2. MAINTENANCE ACTION COMPLETED: REQUIRED PARTS NOT DRAWN FROM SUPPLY 3. MAINTENANCE ACTION COMPLETED: NO PARTS REQUIRED 4. CANCELLED - DEFERRAL WILL BE REMOVED FROM CSMP 5. MAINTENANCE ACTION COMPLETED: 3-M CAPABILITY UTILIZED 6. NONE OF THE ABOVE, DESCRIBE IN REMARKS/DESCRIPTION SECTION		1. MANDATORY 2. ESSENTIAL 3. HIGHLY DESIRABLE 4. DESIRABLE <b>4</b>	
<b>DISCREPANCY DESCRIPTION: PER SEMAT II UNDERWATER HULL ASSESSMENT: EMERGENCY GENERATOR ROOM 1 (4-52-2-A)</b>					
APPROX 50 SQF OF MILD CORROSION AND PAINT SEPARATION ON DECK, SHELL AND BLKHD (68) AFT OF ELECTRICAL PANELS.					
<b>RECOMMENDED REPAIRS: RECOMMEND SHIPS FORCE POWER CLEAN AREA TO BARE METAL, PRIME AND PAINT. APPROX 50 SQF</b>
